Property Inspection Report

1111 Any Street, Rock Hill, SC
Inspection prepared for: John & Jane Smith
Date of Inspection: 5/12/2016

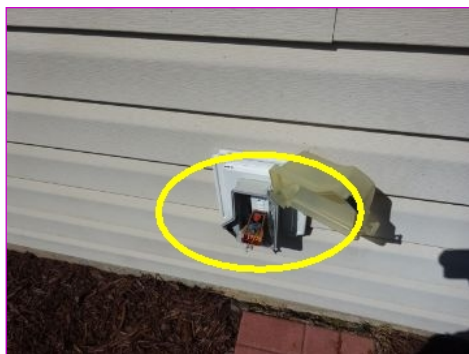
- An exterior Ground Fault Circuit Interrupter (**GFCI**) electrical receptacle at the right side of the homedid not respond to the test button. The Inspector recommends replacement with a new GFCI receptacle by a qualified electrical contractor.

GFCI did not respond to test button. Have repaired by qualified electrical contractor.

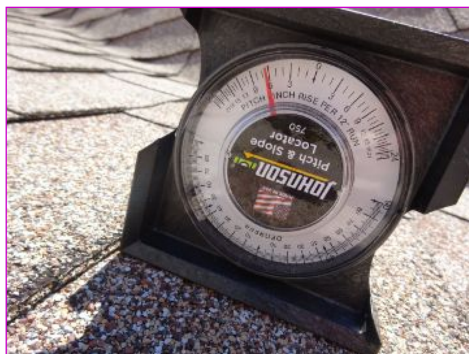
8 in 12 Pitch.

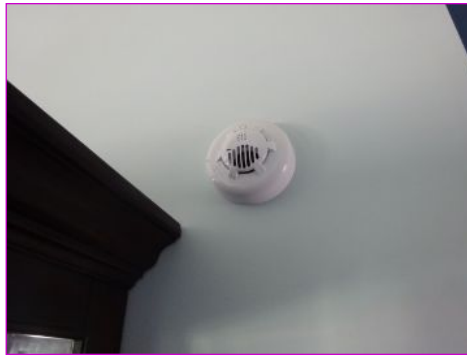
GENERAL INTERIOR Smoke/CO Detectors

- Smoke detector placement appeared to be adequate. Smoke detectors are not tested as part of a general home inspection. The Inspector recommends that all detectors be checked to confirm that they don't need battery replacement.

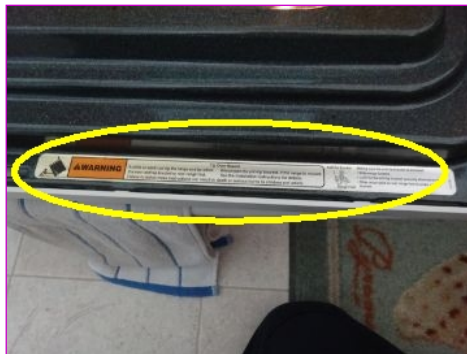
- The range was not fastened to the floor. A child standing on the open oven door could overturn the range. This condition is a life-safety issue. The Inspector recommends installation of an approved anti-tip device by a qualified contractor.

Safety Concern. Anti-tip not installed for range. Have repaired by qualified contractor.

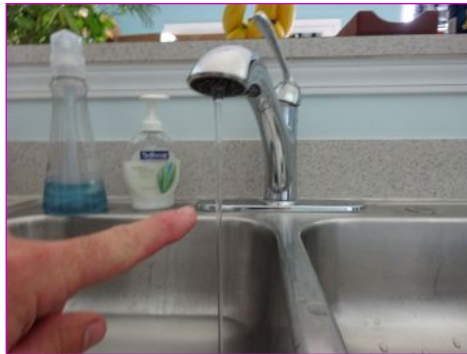
- The kitchen sink had inadequate water flow at the time of the inspection. The Inspector recommends evaluation and any necessary work be performed by a qualified plumbing contractor.

Low hot water flow at kitchen sink.

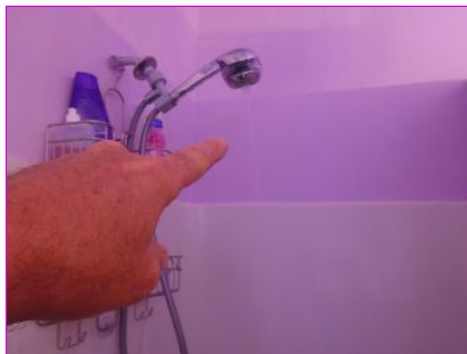
- Water flow at the shower in this bathroom appeared to be inadequate. The Inspector recommends that you have this condition evaluated by a qualified plumbing contractor to determine the potential need and costs for correction.

Low flow at shower while tub faucet running.

Page 9 Item: 3	Shower	<ul style="list-style-type: none"> Water flow at the shower in this bathroom appeared to be inadequate. The Inspector recommends that you have this condition evaluated by a qualified plumbing contractor to determine the potential need and costs for correction.

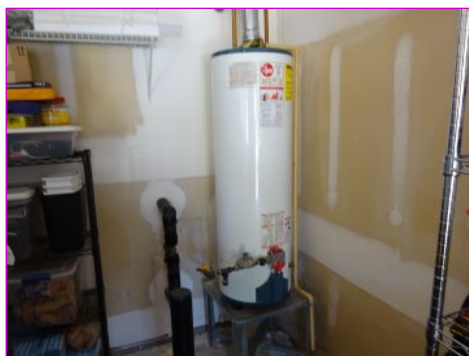
Nat. Gas Water Heater located in Garage.

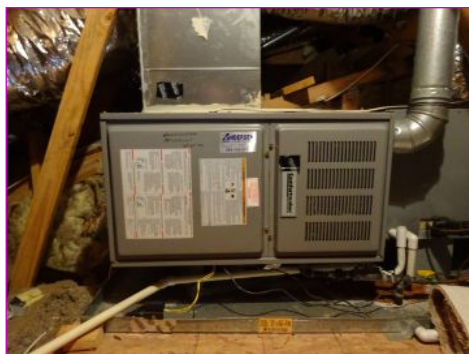
Nat Gas fired furnace located in attic.

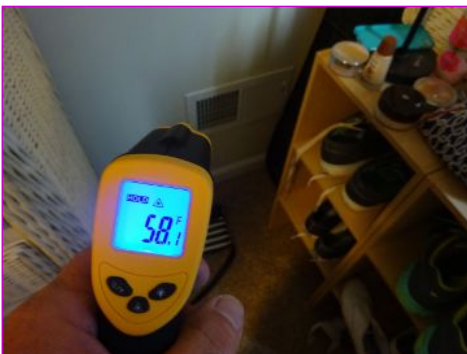
- The differences in air temperature measured at supply and return registers fell within the acceptable range of between 14 and 22 degrees F.

58 degrees at supply in cooling mode.

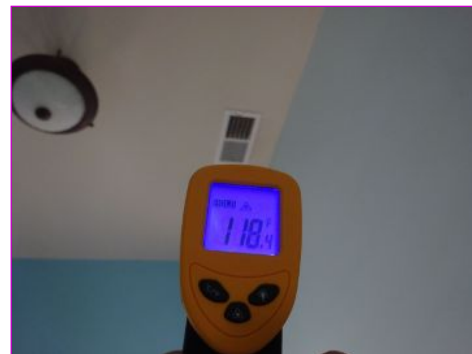
118 degrees at supply when heat was on.

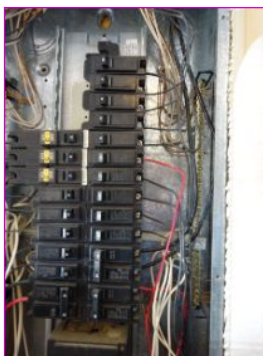
200 amp service.
